Manhole Inspection Summary

Manhole # S07MM1004MH

Insp Date: **7/1/09 10:47 AM**

Location Address: **3328 W GARRISON AVE**

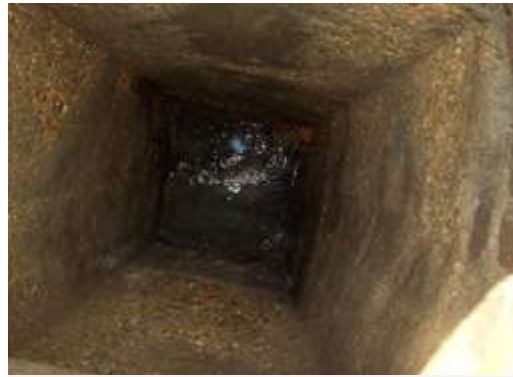
Top View

Comments **SQUARE BARREL CHANNEL NOT VISIBLE CLEANING REQUIRED**

CHANNEL NOT VISIBLE

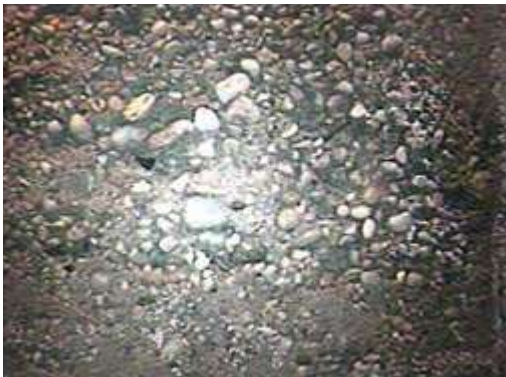
Defect 1

Condition: ☐ Sound ☒ **Cracked** ☐ Root Intrusion ☐ Loose Brick ☒ **Deteriorated**

DETERIORATED AGGREGATE IN
BARREL

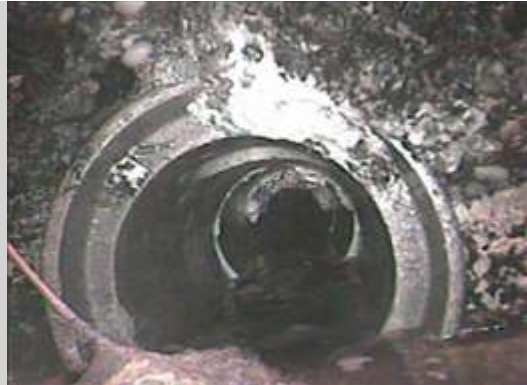
12 O'Clock Outflow

10 in. Circular Gravity Sewer
Pipe Out @ 12 O'Clock

Pipe Height: **7.2** (in.) Rod and Bar
Pipe Material: **Unknown** ☐ Pipe Lined
Invert Depth: **13.71** (ft.) Flow Characteristics: **Slow**
Deposits: ☐ None ☐ Mud ☒ **Sludge** ☐ Debris ☒ **Grease**
Silt Depth: **4** (in.) Deposits Extent: **Heavy**
Infiltration: **None** Pipe Seal Cond: **Broken**

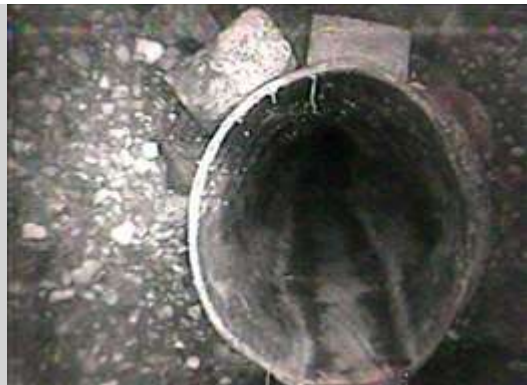
5 O'Clock Inflow

10 in. Circular Gravity Sewer
Pipe In @ 5 O'Clock

Pipe Height: **7.2** (in.) Rod and Bar
Pipe Material: **Clay** ☐ Pipe Lined
Invert Depth: **12.81** (ft.) Flow Characteristics: **Slow**
Deposits: ☒ **None** ☐ Mud ☐ Sludge ☐ Debris ☐ Grease
Silt Depth: (in.) Deposits Extent:
Infiltration: **None** Pipe Seal Cond: **Broken**

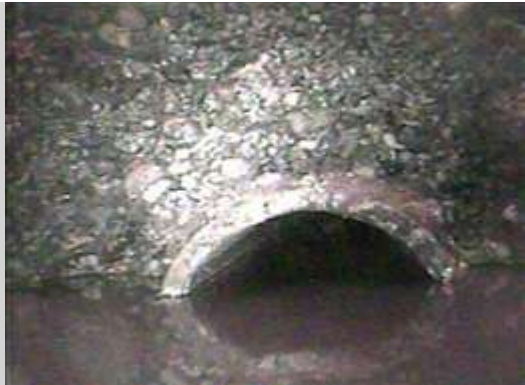
9 O'Clock Inflow

10 in. Circular Gravity Sewer
Pipe In @ 9 O'Clock

Infiltration: **None** Pipe Seal Cond: **Unknown**
